Your Home Inspection Report

David Small 156 Inagehi Way Loudon, TN 37774 3/24/2021

Bentley and Associates LLC Prepared for: 156 Inagehi Way

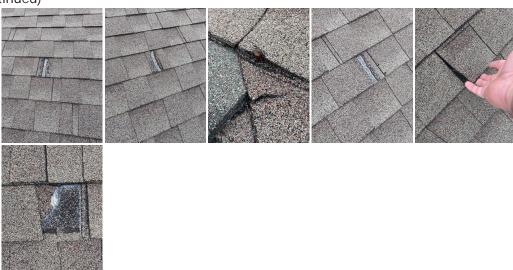
- 2. Method of Inspection: On roof
- 3. Defective Material: Asphalt shingle Damaged shingles, Shingles not sealing in areas, A qualified roofing contractor is recommended to evaluate and estimate repairs

4. Main Roof Surface Material: Asphalt shingle - Damaged shingles, Shingles not sealing in areas, A qualified roofing contractor is recommended to evaluate and estimate repairs

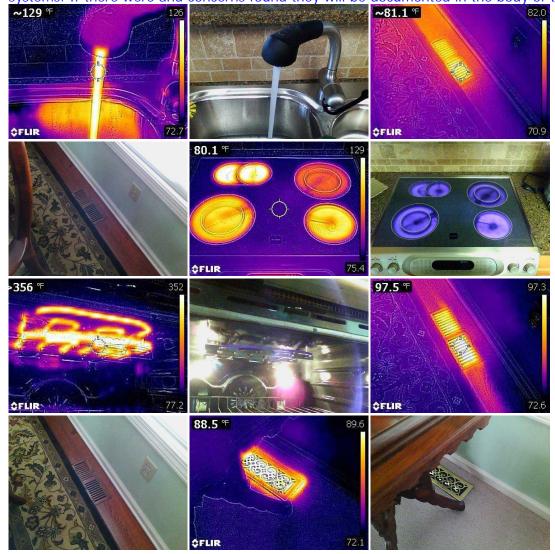
Building Scan No concerns were noted in scan - This is for your information and is not a complete energy scan of the home. These are some pictures we took to provided you a better and more thorough inspection report. Infrared cameras are very effective at documenting consistent temperature change and can be used to show operational status of appliances and mechanical systems. If there were and concerns found they will be documented in the body of the report.

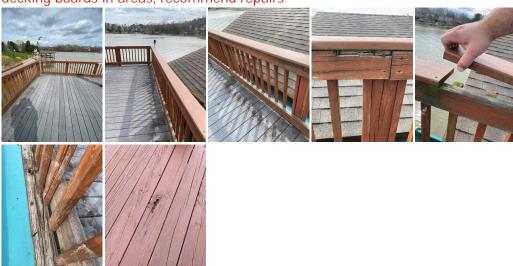
Dock: Treated wood, Composite decking - Loose/damaged/rotted handrails, wood rot noted at decking boards in areas, recommend repairs

12. Lake Docks/Seawalls Dock: Treated wood, Composite decking - Loose/damaged/rotted handrails, wood rot noted at decking boards in areas, recommend repairs
